REPORT DOCUMENTATION PAGE		READ INSTRUCTIONS BEFORE COMPLETING FORM
1. REPORT NUMBER	2. GOVT ACCESSION NO.	3. RECIPIENT'S CATALOG NUMBER
AD-A091141		
4. TITLE (and Subtitle) Phase I Inspection Report Ischua Creek Watershed Project Site 6A Allegheny River Basin, Cattaraugus County, NY Inventory No. 571		5. TYPE OF REPORT & PERIOD COVERED Phase I Inspection Report National Dam Safety Program

ALLEGHENY RIVER BASIN

ISCHUA CREEK WATERSHED PROJECT  
SITE 6A

INVENTORY NO. N.Y. 571

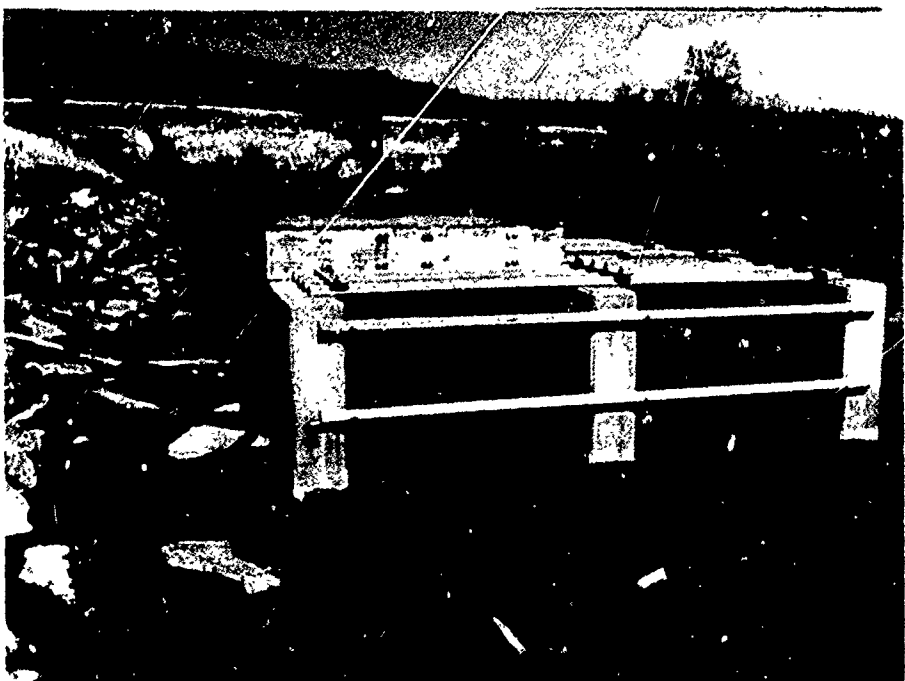
The reservoir is drained by a 30 inch I.D. reinforced concrete pipe and a manually operated slide gate with the gate stem situated at the top of the east drop inlet structure. The slide gate is in an operable condition, however, when fully closed, leakage estimated at between 10 and 20 gallons per minute passes around the gate.

Close-up of intake structure  
and reservoir drain gate  
operating stem.
